Manhole Inspection Summary

Manhole # S51GG_004MH

Insp Date: **6/6/08 11:34 AM**

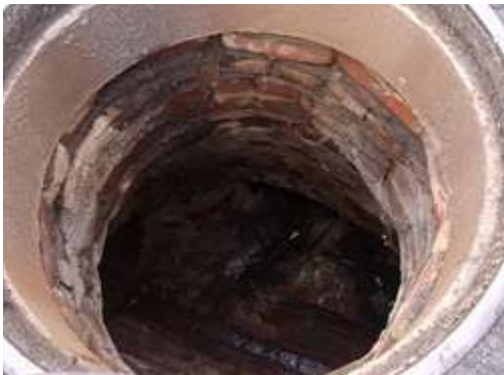
Defect 1

☒ **Leaks**

FRAME LEAKS

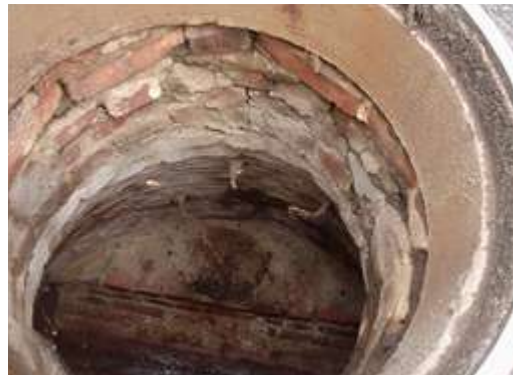
Defect 2

Condition: ☐ Sound ☐ Cracked ☐ Root Intrusion ☒ **Loose Brick** ☐ Deteriorated

Infiltration: ☐ None ☐ Joint ☐ Cracks ☒ **Mortar** ☐ Roots ☐ Wall

LOOSE BRICKS

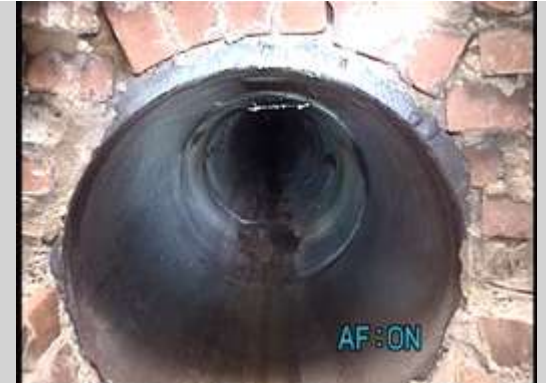
12 O'Clock Outflow

21 in. Circular Gravity Sewer
Pipe Out @ 12 O'Clock

Pipe Height: **21.6** (in.) Rod and Bar (Angled)
Pipe Material: **Clay** ☐ Pipe Lined
Invert Depth: **6.55** (ft.) Flow Characteristics: **None**
Deposits: ☒ None ☐ Mud ☐ Sludge ☐ Debris ☐ Grease
Silt Depth: (in.) Deposits Extent:
Infiltration: **None** Pipe Seal Cond: **Sound**

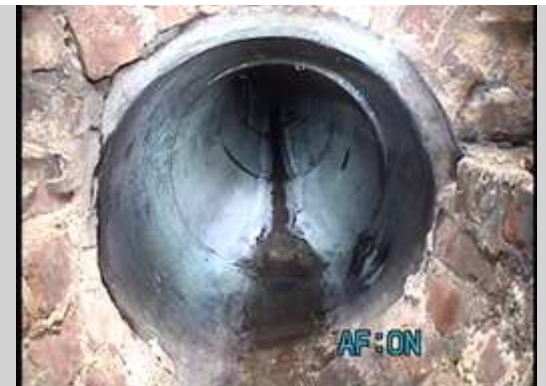
3 O'Clock Inflow

15 in. Circular Gravity Sewer
Pipe In @ 3 O'Clock

Pipe Height: **15.6** (in.) Rod and Bar (Angled)
Pipe Material: **Clay** ☐ Pipe Lined
Invert Depth: **6.35** (ft.) Flow Characteristics: **None**
Deposits: ☒ None ☐ Mud ☐ Sludge ☐ Debris ☐ Grease
Silt Depth: (in.) Deposits Extent:
Infiltration: **None** Pipe Seal Cond: **Sound**

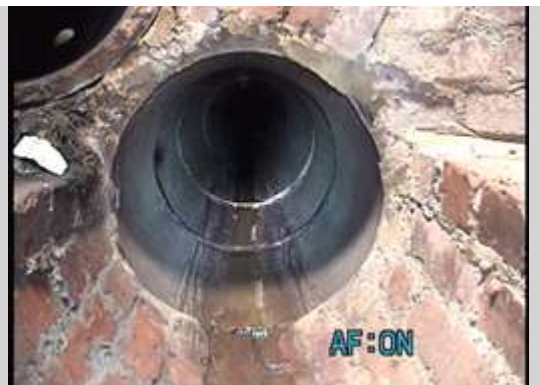
6 O'Clock Inflow

15 in. Circular Gravity Sewer
Pipe In @ 6 O'Clock

Infiltration: **None**

Pipe Seal Cond: **Sound**
